HYDRAULIC MODEL STUDIES OF  
FONTENELLE DAM SPILLWAY  
SEEDSKADEE PROJECT, WYOMING

Hydraulic Laboratory Report No. Hyd-486

DIVISION OF ENGINEERING LABORATORIES

February 19, 1962

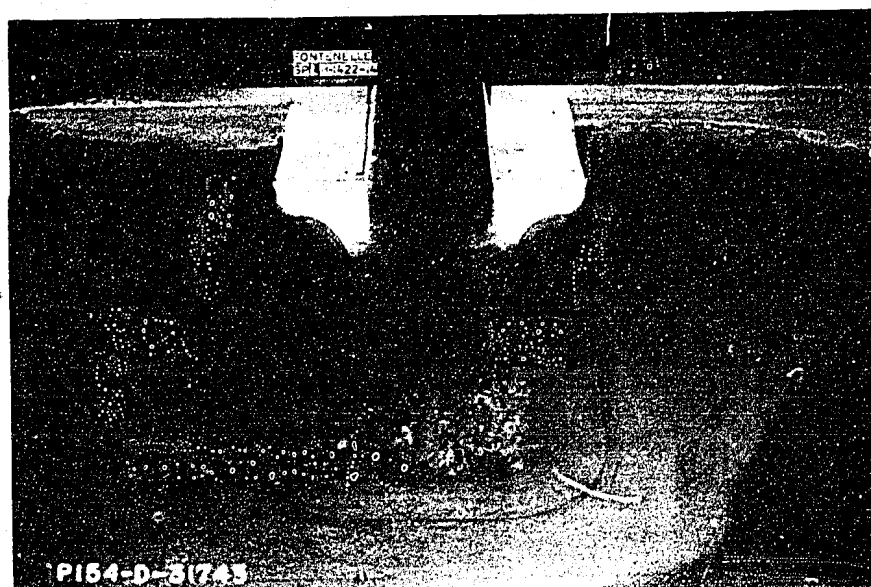
Figure 7  
Hyd 486

$Q = 5,000 \text{ cfs}$

$Q = 10,000 \text{ cfs}$

FONTENELLE DAM SPILLWAY  
HYDRAULIC MODEL STUDIES  
1:30 Scale Model  
Low Flows in Spillway Basin  
Preliminary Design

Preliminary Design. --The model was operated with the original layout to determine the flow conditions over a complete range of discharges. For 5,000 second-feet the flow appearance was excellent. The flow from the reservoir approached the spillway in a smooth, well-distributed pattern. The flow from both sides of the crest came together in the center of the spillway basin and formed a small standing wave. There was only a slight drawdown of the flow around the piers. By the time the flow passed through the rectangular passage downstream from the piers, the standing wave had smoothed out and the flow was symmetrical, Figure 7.

When the discharge was increased to 10,000 second-feet, the appearance of the flow approaching and passing over the crest was still excellent. However, the standing wave formed by the intersection of the flows from opposite sides of the spillway was slightly to the right of center, indicating that more flow was passing over the left side of the spillway than over the right side, Figure 7. There was still only a slight drawdown in the water surface adjacent to the piers. The slight drawdown smoothed out as the flow passed through the rectangular section.

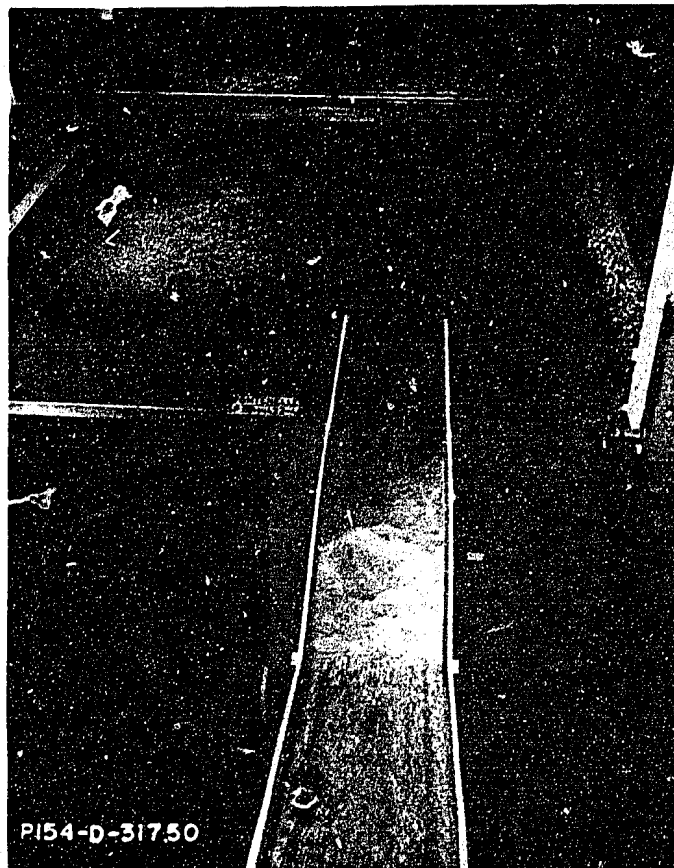
PI54-D-31750

Q = 5,000 cfs, T.W. = el. 6395.20
